Seriously, you couldn't call first?

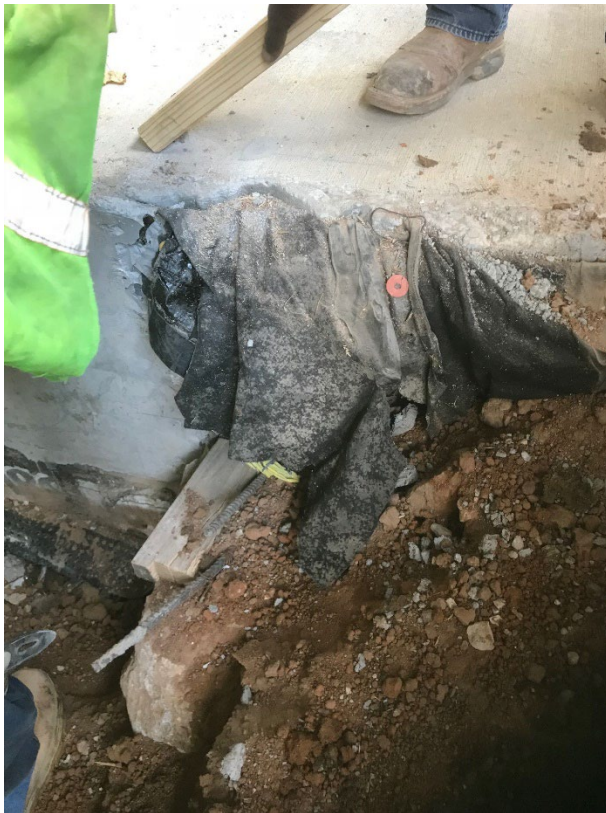
We have a project right now that has Underseal pre-applied below grade waterproofing on the foundation wall of a parking garage that will be tying into the podium deck waterproofing. The situation occurred after the concrete contractor had finished placing curbing around the podium deck. (Fig. 1) The purpose of pre-applied waterproofing is to maximize the property usage by casting the concrete wall against it, eliminating the need for the wasted space of a trench. The membrane from the top of the shoring wall down (which was never intended to see the light of day) is sandwiched between the concrete wall and the surrounding shoring wall. The difficulty is that a flap of excess membrane of the pre-applied waterproofing must be left exposed above the shoring wall in the transition area and remain viable so it can be tied into the podium waterproofing at a later time. Obviously, that objective was not achieved.

How could such an important detail, such as the transition strip used to connect the two systems, be completely disregarded, and wadded up in the corner? The biggest reason is that only a handful of people really understand why that flap of random membrane hanging out there is so important. In this case, the concrete contractor didn't understand that flap was the critical connector piece for the two different systems. Because the overarching goal is to "get the work done," the concrete crew cut the membrane off at the top of the shoring wall and wadded the vertical leg up into the corner of the form making it completely unusable. It is critical junctions, just like this situation, that 90% of all water intrusion has been documented to occur. Considering the multiple trades and various connections between the numerous systems, it is easy to see why most leaks happen at those critical junctions better known as terminations, transitions, and penetrations.

What is the fix for a situation like this one? Unfortunately, the correction is often demanding and sometimes completely unreasonable to perform. We see it every day. Major grade beams cast without waterproofing. Large banks of utility lines run through the waterproofing without be detailed. Truly, the only way to properly correct those situations is to jack out the concrete and start over. Rarely can a project absorb the additional cost or delayed schedule to make such extensive corrections. In the pictured situation example, the fill under the podium deck must be excavated exposing the membrane to install a transition membrane. Let's face, when we must correct a situation, the fix is expensive and time consuming, and would have been simpler to address prior to actual construction.
